PHASE I ENVIRONMENTAL SITE ASSESSMENT

**305-317 Pennsylvania Avenue
Block 7102, Lots 7 & 8
Paterson, New Jersey 07503**

**LAN Associates, Engineering, Planning, Architecture, Surveying, Inc.
445 Godwin Avenue
Midland Park, NJ 07432
(201) 447-6400 – TELEPHONE
(201) 447-1233 – FACSIMILE**

LAN Job #2.3842.03
November 4, 2008

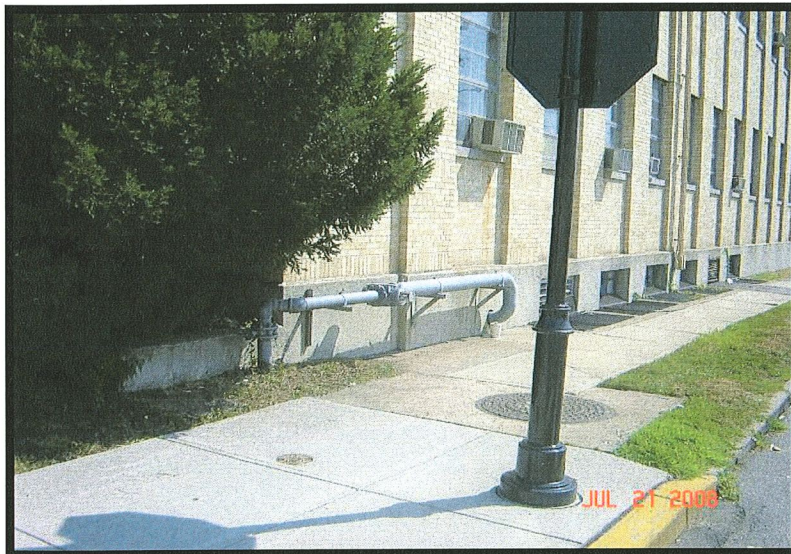
Photo No. 10

View of new concrete sidewalk located at the intersection of Pennsylvania Avenue and Buffalo Avenue. Photo shows gas supply into the building. The photo also shows monitoring well present in the sidewalk. It is presumed that the monitoring well is from a former investigation related to removal of an underground heating oil tank.

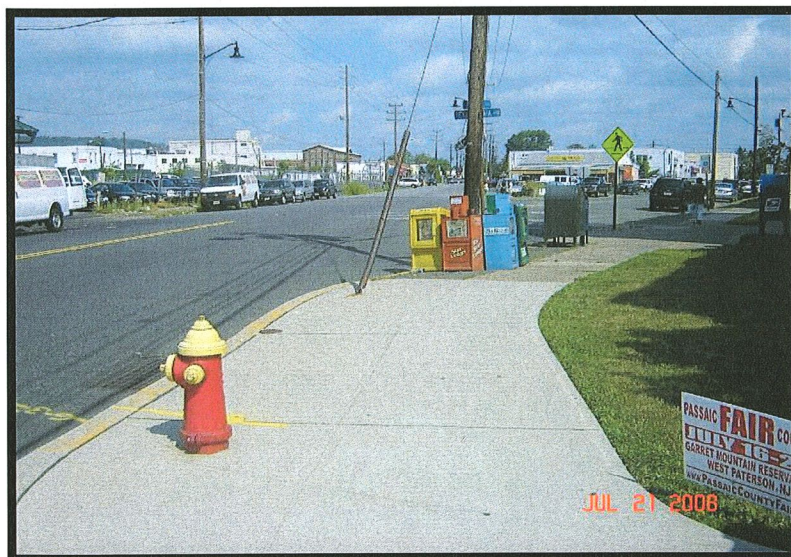
Photo No. 11

View looking to the north from Buffalo Avenue. The photo shows the remaining portion of the new concrete sidewalk seen in photo 10. An additional monitoring well is seen near the curb.

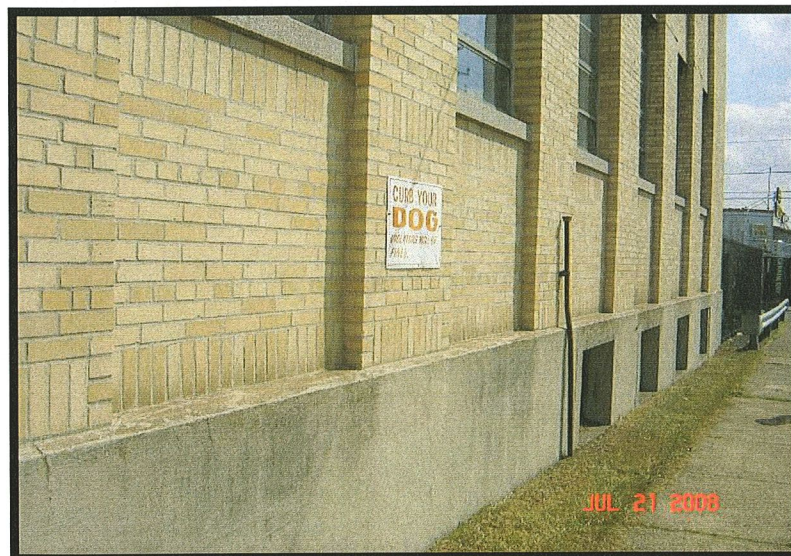
Photo No. 12

View of the vent stack located on the south side of the office building, toward the east end. Underground storage tank is presumed to be removed from this location. Fill cap could not be located.

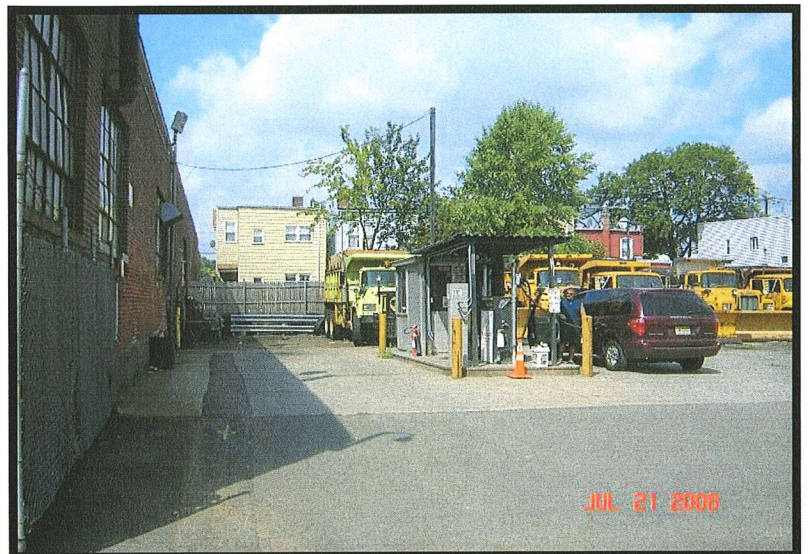
Photo No. 18

1. Integrity tests should be performed on these active USTs to verify that there are no leaks associated with these tanks. Until it can be determined that there are no leaks associated with these tanks, these tanks represent a recognized environmental condition.

View looking west at the fueling area. Dispenser island with gasoline and diesel dispenser are present. Three underground storage tanks are located to the right of the dispensers.

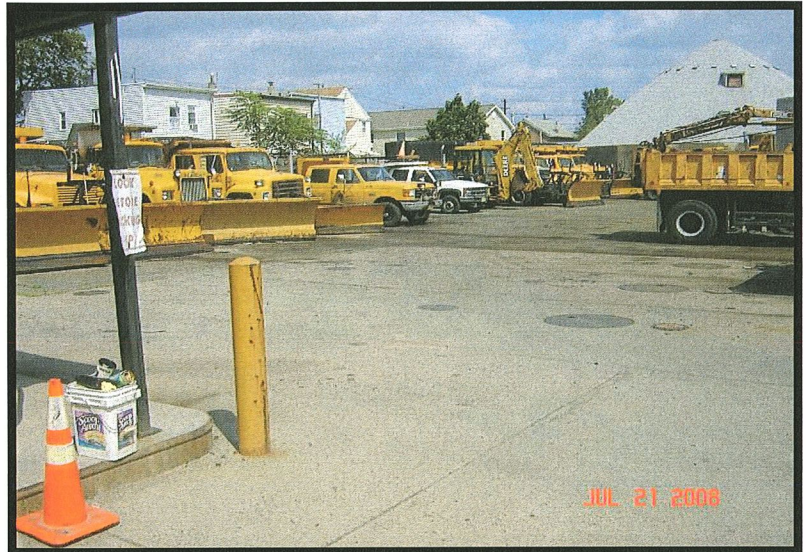
Photo No. 19

View of the concrete slab above the three underground storage tanks.

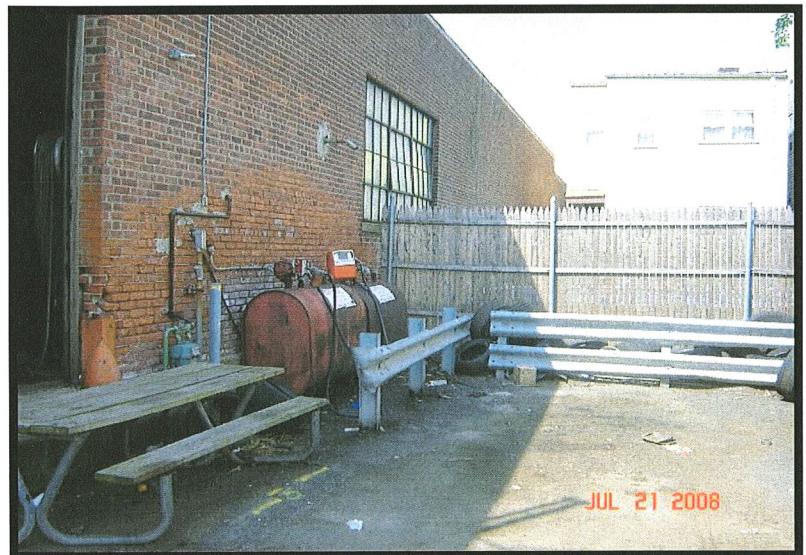
Photo No. 20

9. The kerosene tanks are in good condition, and there are no signs of leaking or staining. As such, the kerosene tanks are not a recognized environmental condition.

Two, 275 gallon aboveground tanks located against the north wall of the garage building.

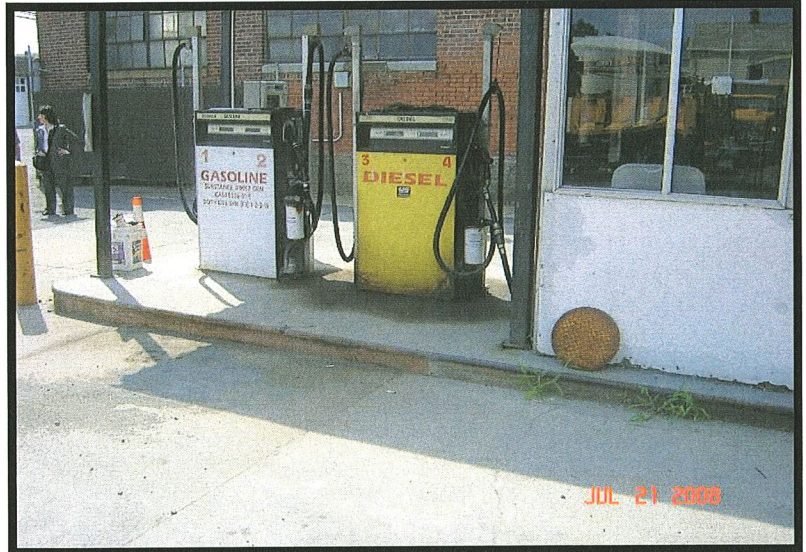
Photo No. 22

View of the dispensing area. Staining is present around the diesel dispenser.

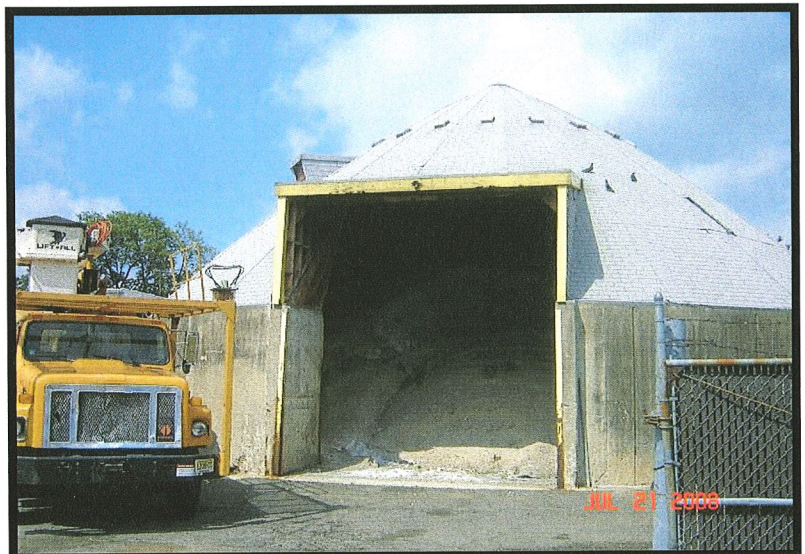
Photo No. 24

14. The salt storage dome is in good condition, and there are no signs of leaking or staining. As such, the salt storage dome does not represent a recognized environmental condition.

View of the salt storage dome located near the extreme north end of the parking area.

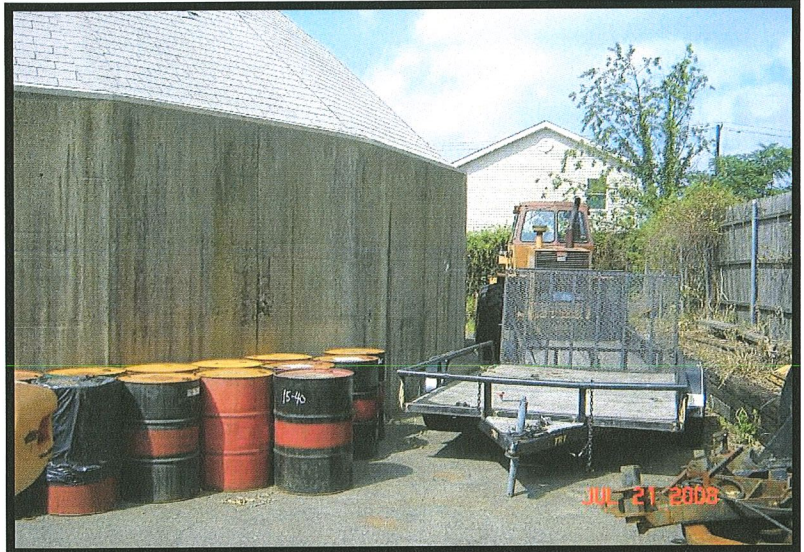
Photo No. 25

View of the empty 55 gallon hydraulic oil drums stored adjacent to the salt storage dome.

17. The empty 55-gallon hydraulic oil drums are in good condition and there are no signs of leaking or staining. As such, the empty oil drums are not a recognized environmental condition. However, it is recommended that the empty oil drums be removed from the premises.

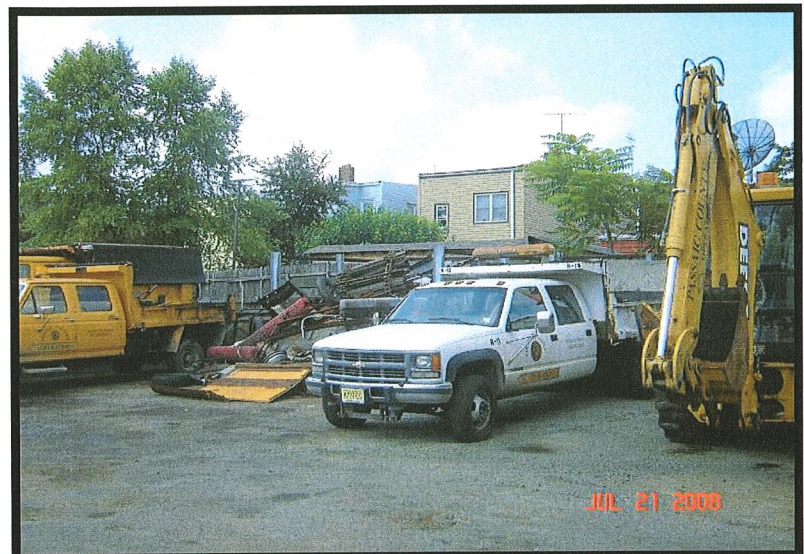
Photo No. 27

View of the scrap metal pile located along the west fence line of the parking area.

11. There are no hazardous materials located in the scrap metal pile. As such, the pile does not represent a recognized environmental condition. However, the scrap metal should be removed from the subject site.

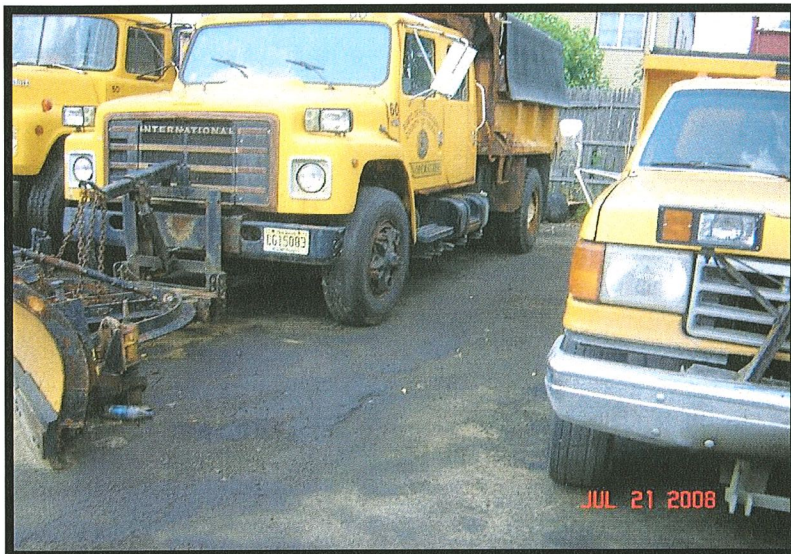
Photo No. 28

15. There is a calcium chloride storage tank in the northern portion of the parking area fronting Columbia Avenue.
16. There are signs of oil staining in the asphalt paved truck parking area on the northern portion of the site.

16. The asphalt paved truck parking area is cracked and worn. As such, the staining in the asphalt paved truck parking area represents a recognized environmental condition.

View of oil staining of the asphalt paved area in the truck parking area.

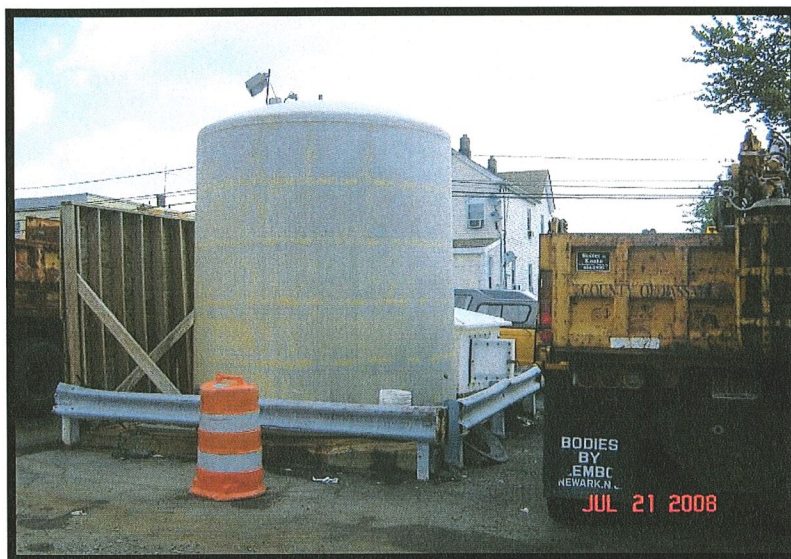
Photo No. 29

15. The calcium chloride storage tank is in good condition, a concrete pad is beneath it, and there are no signs of leaking or staining. As such, the calcium chloride storage tank does not represent a recognized environmental condition.

View of the aboveground calcium chloride storage tank.

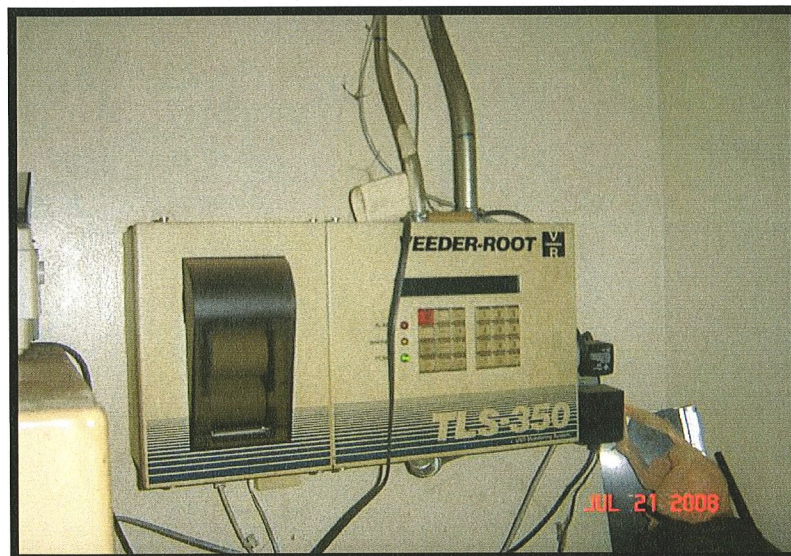
Photo No. 30

View of the Veeder-Root underground storage tank leak detection system for the underground gasoline and diesel tanks.

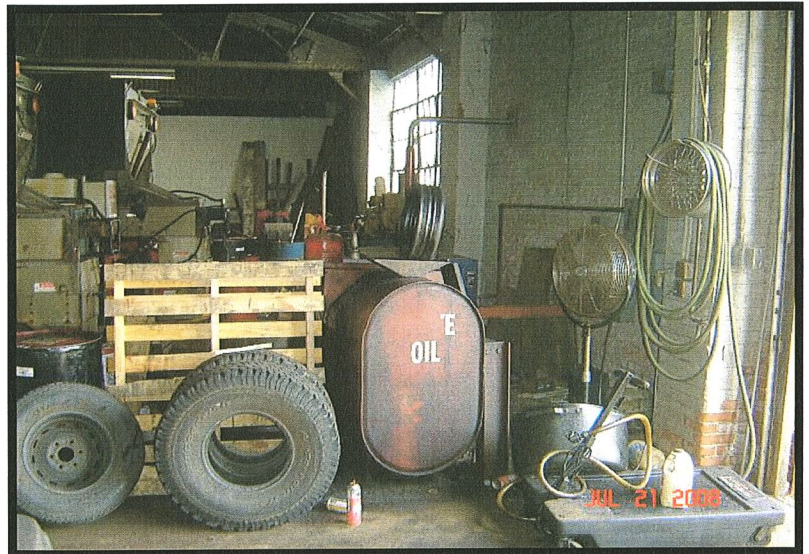
Photo No. 31

View of waste oil storage and various lubricant drums and containers present within the garage building.

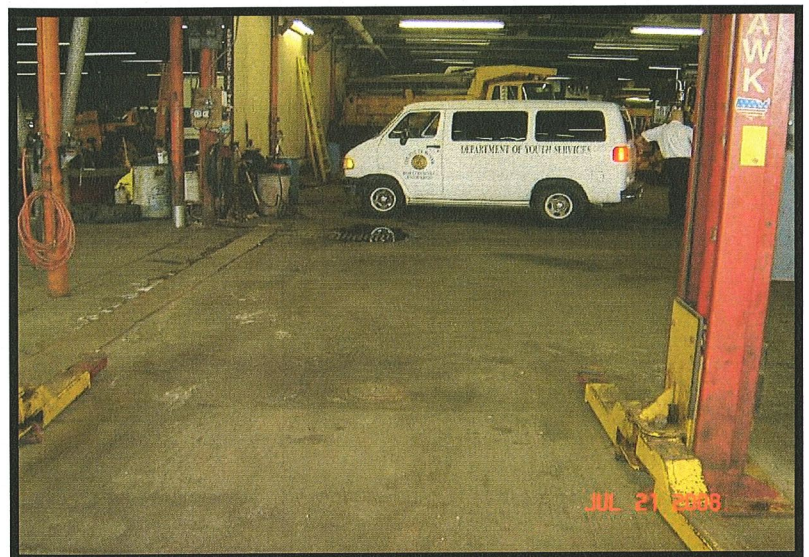
Photo No. 32

18. The floor-mounted lifts are in good condition, with no signs of leaking or staining. As such, the floor-mounted lifts do not represent a recognized environmental condition.

View looking to the west within the northern portion of the garage. Photo shows floor mounted hydraulic lifts on the foreground. There is a cylinder from the former below grade lift cemented in the foreground. A catch basin is present in the background. Standing water was present.

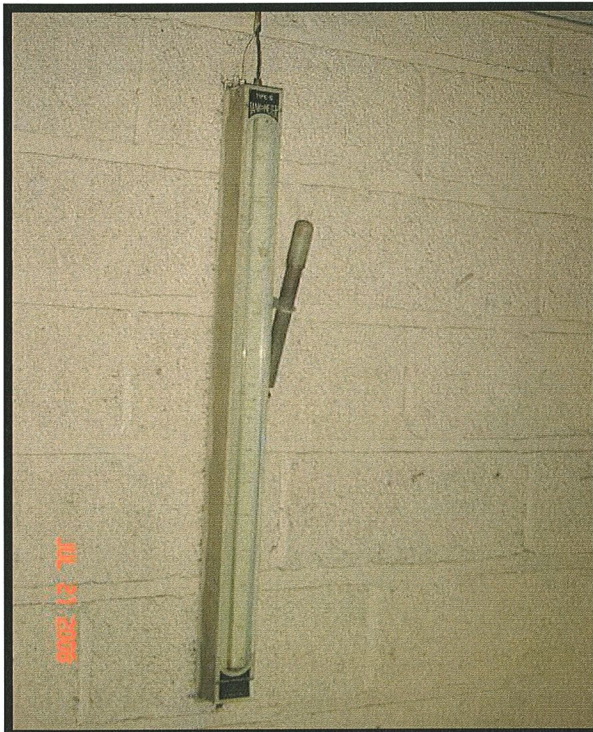
Photo No. 36

Level gauge is present in the boiler room for the office building. The level gauge remains from the former underground storage tank. The level gauge indicates a 12,000 gallon capacity.

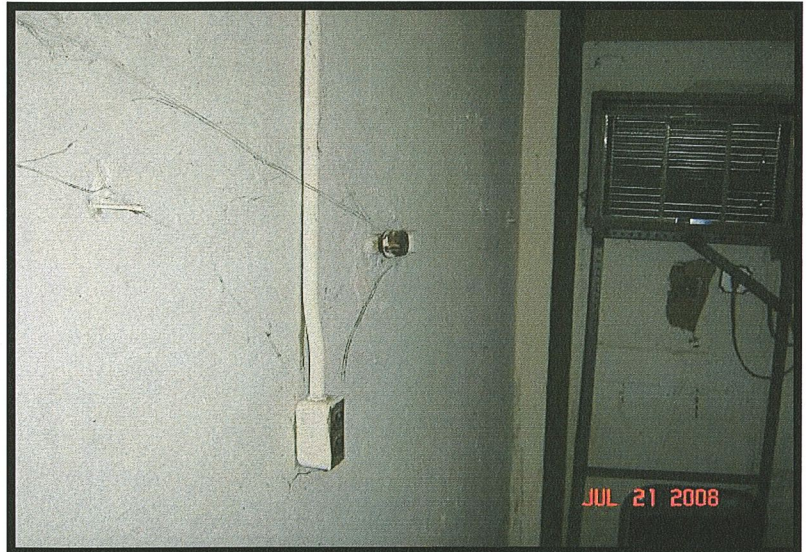
Photo No. 38

View of two capped pipes from a former fuel oil tank. The capped pipes are in the vicinity of the vent stack seen in Photo No. 12.

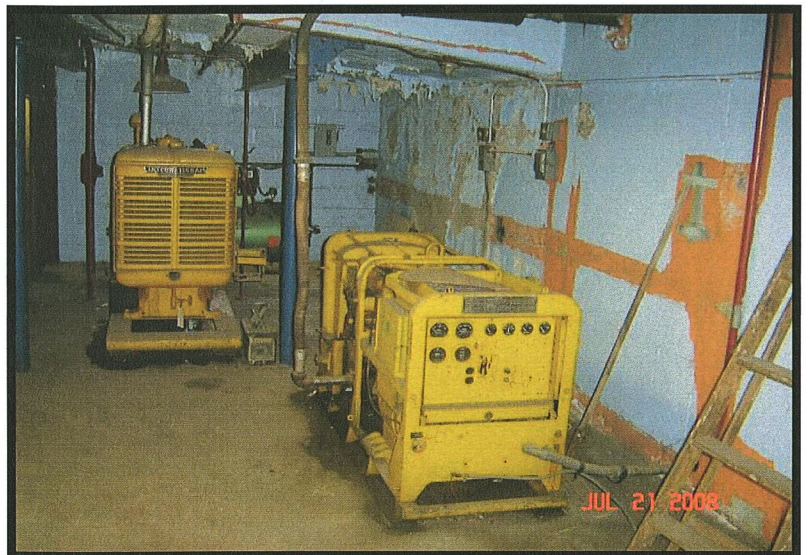
Photo No. 39

19. The emergency generators are gas-fired and utilize self-contained fuel tanks. The tanks are in good condition, with no signs of leaking or staining. As such, the fuel tanks for the generators do not represent a recognized environmental condition.

Two gasoline driven emergency generators located in the boiler room located in the basement level of the garage building. The basement area is centrally located on the east side of the garage. The generators have self contained gasoline tanks.

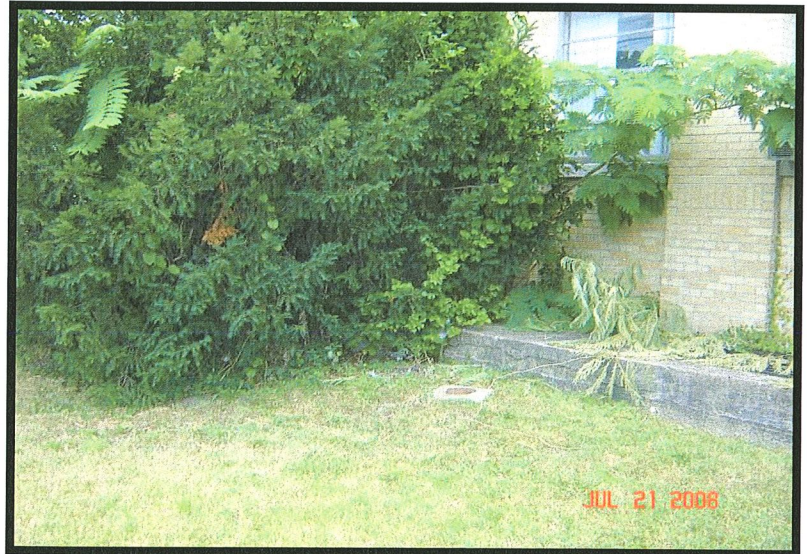
8. The monitoring wells are presumably associated with the active HIST LUST and SHWS cases. As such, the monitoring wells do not represent a separate recognized environmental condition.

View of the monitoring well located in the lawn area to the right of the front steps leading into the office building.
